Proposed repairs to Church of the
Assumption and Saint Laurence O'Toole,
Rathangan, Wexford (*a Protected Structure*)

Architectural Heritage Impact Assessment

MICHAEL TIERNEY
B Arch FRIAI
Conservation Architect Grade I
September 2025

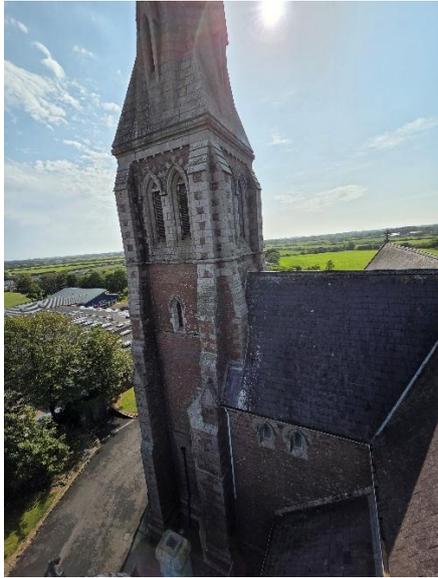
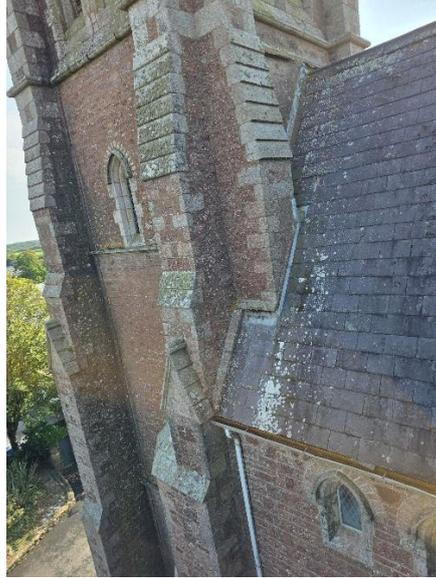
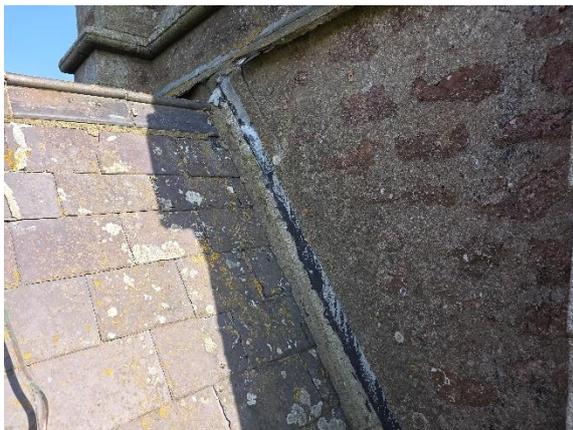
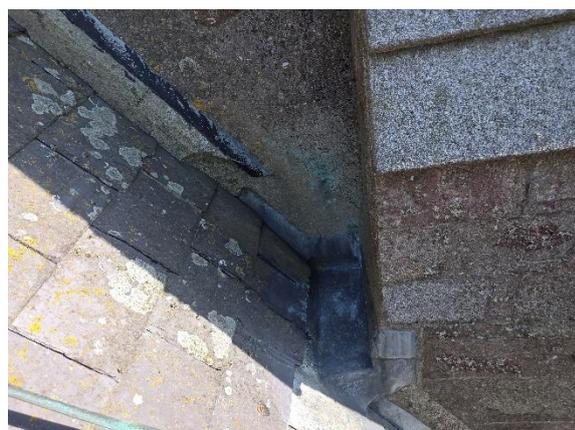
AREA 1 – TOWER TO PRIMARY ROOF JUNCTION

Lead flashing to be redone/missing in some areas.

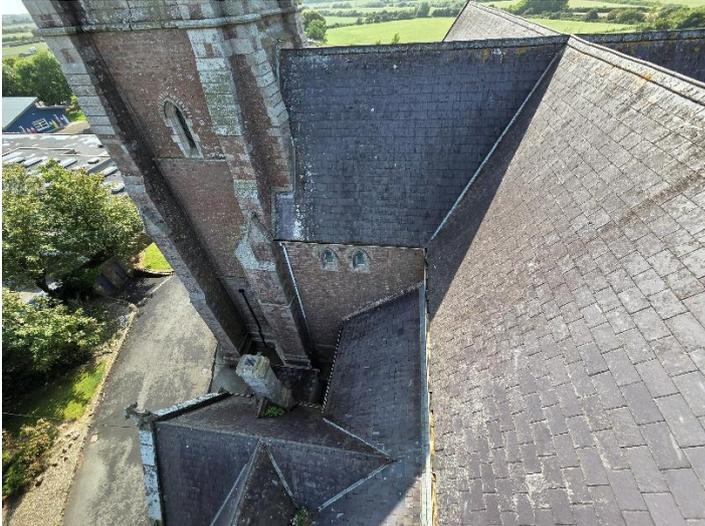
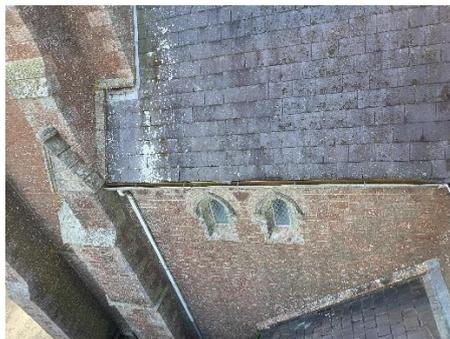
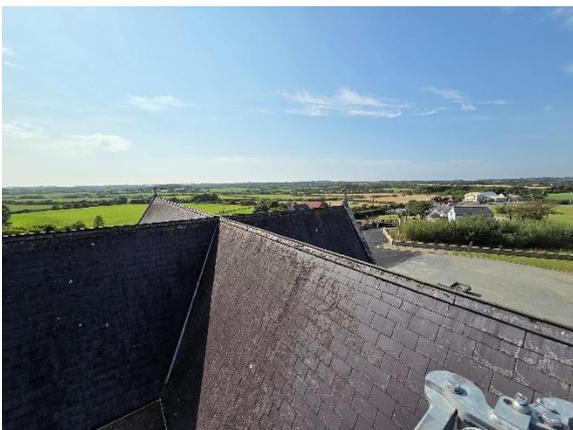
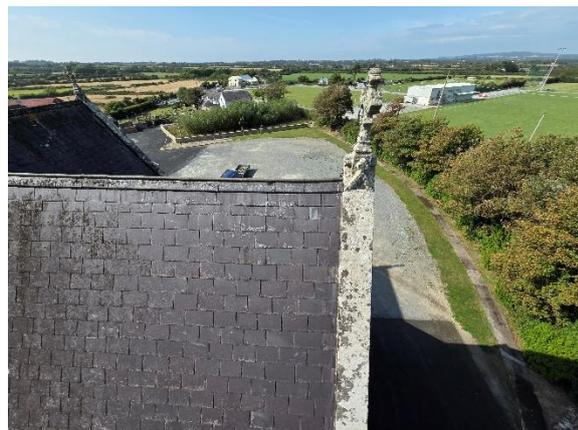
AREA 2 – PRIMARY ROOF

Lead valleys to be repaired.

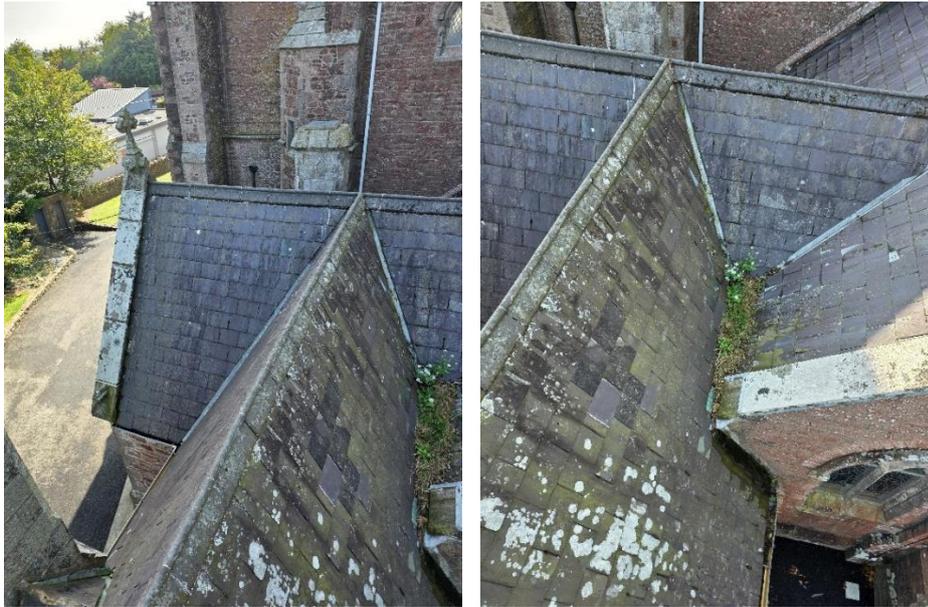
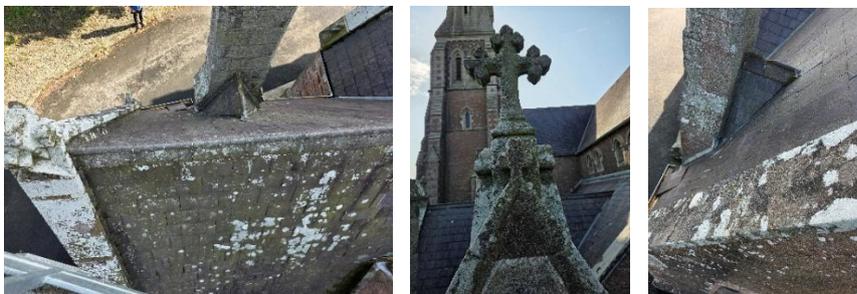
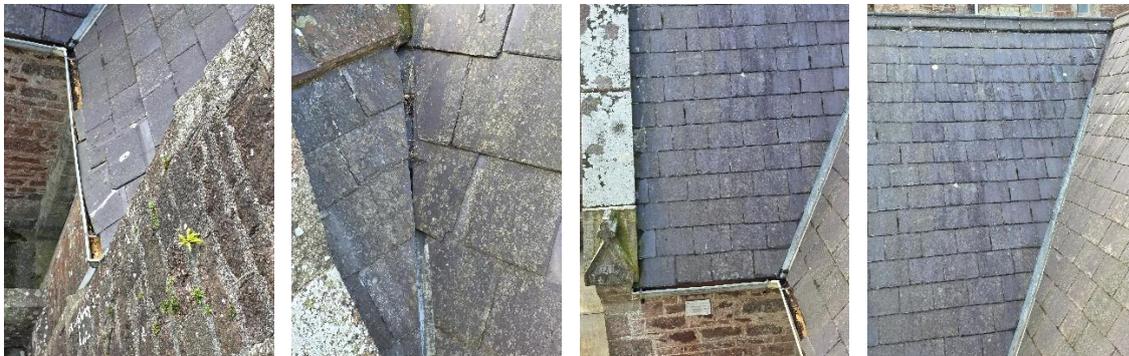
AREA 3 – SECONDARY ROOF TO TERTIARY ROOFS

Vegetation between roof junctions to be cleared out/removed. / Chimney to wall junctions to be inspected for water ingress/evidence of dampness on interior. / Slipping slates at the gutters and valleys.

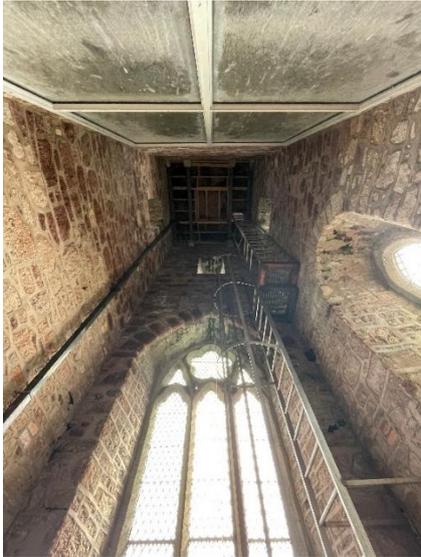
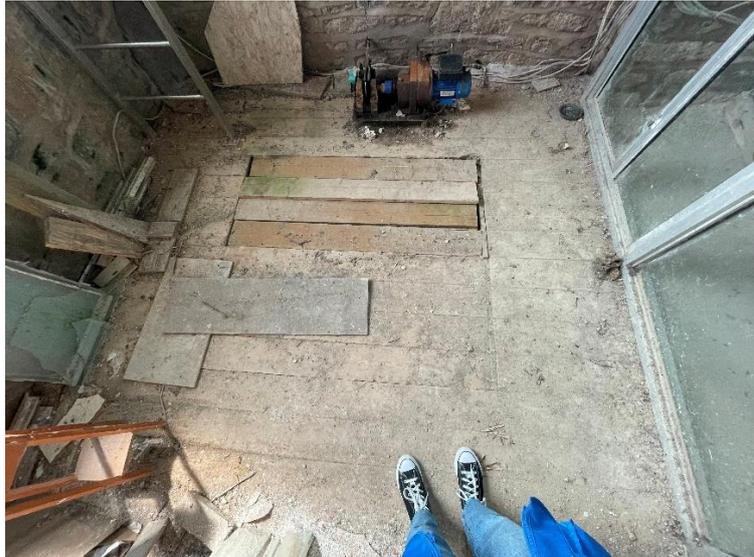
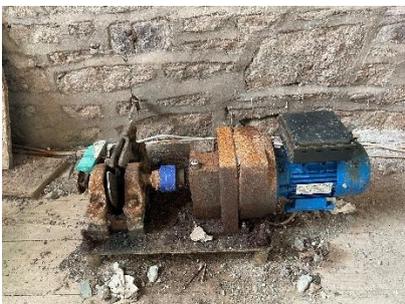
AREA 4 – TOWER INTERIOR

All 3 timber platforms in the tower are to be repaired. Platform 1 shows evidence of damaged and loose timber boards. Water damage from prior to downpipe installation/downpipe may currently be blocked. Existing bell motor to be enclosed in safety cage. Bolts to cat ladder badly corroded and need to be replaced.

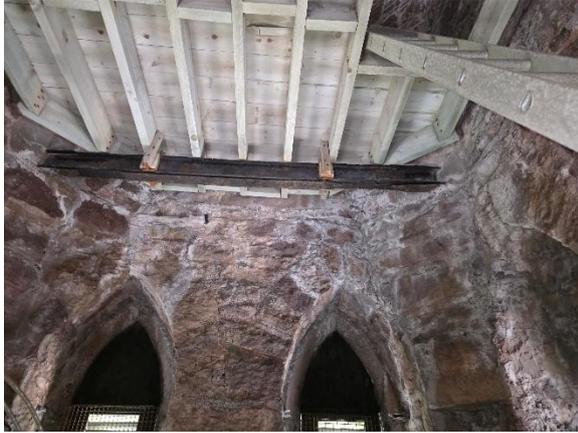
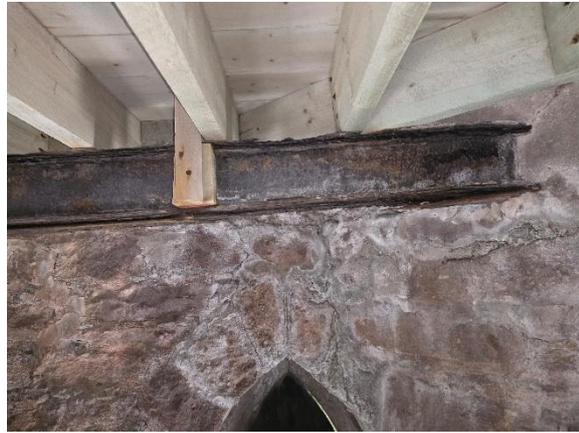
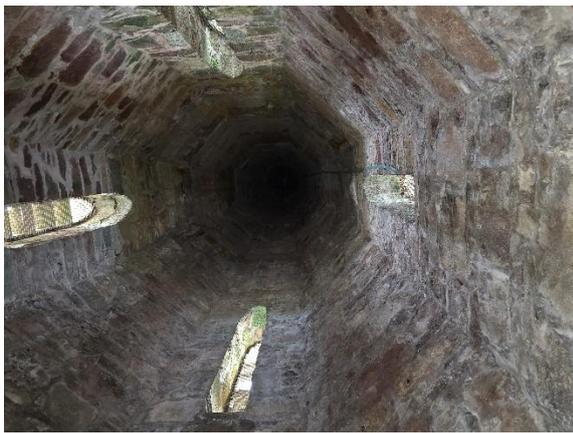
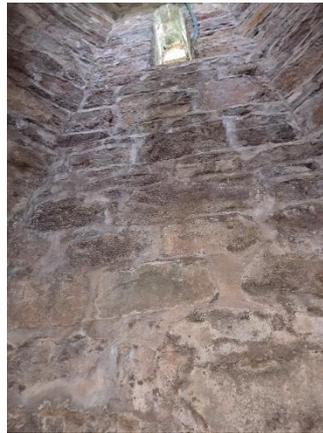
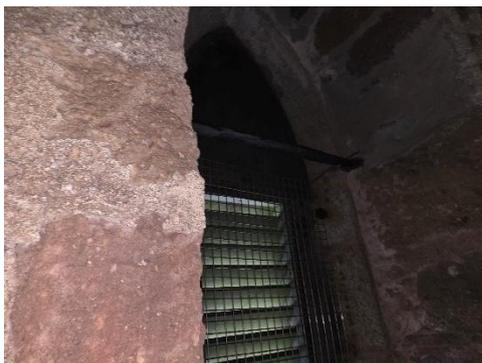
Platform 2 timber boards and joists in good condition, steel support beams below are badly corroded and need to be replaced.

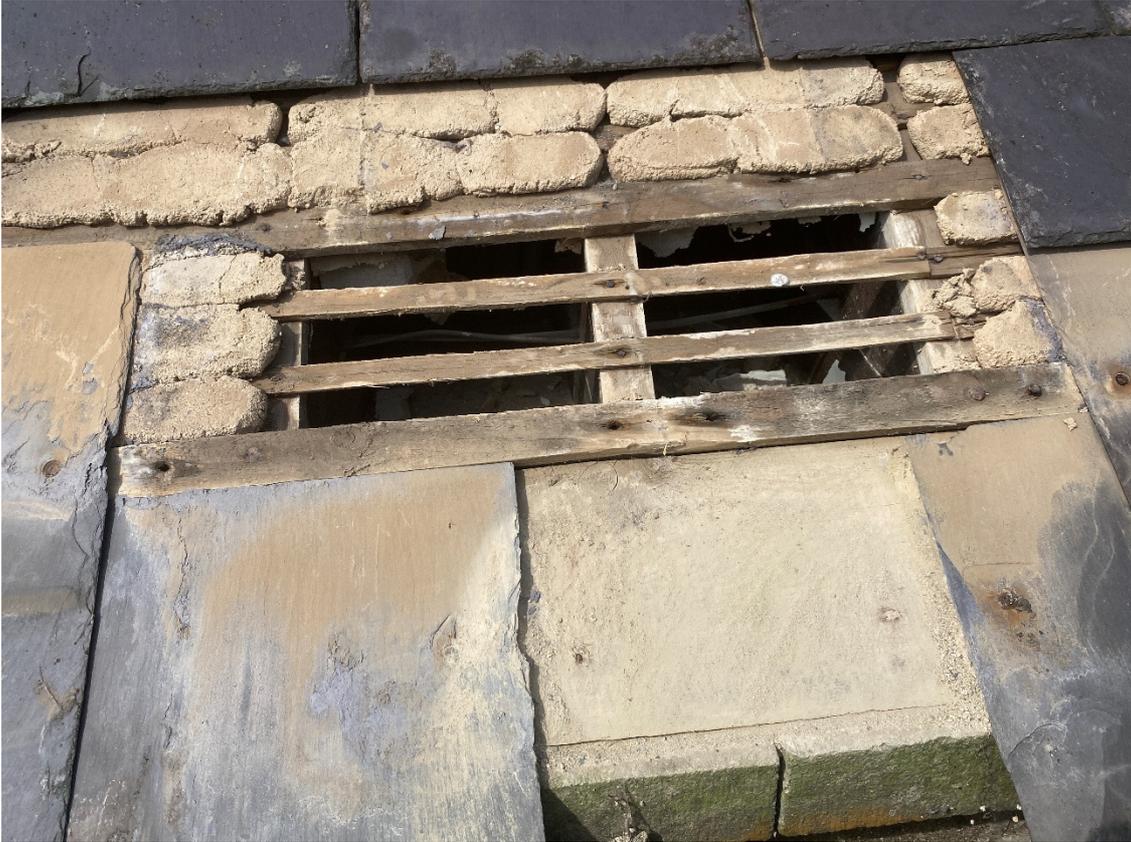
1. Many of the slates have 'slipped' and fallen off the roof. The nails in general are of iron construction and many have rusted through. 'Slipping' slates pose a grave danger to members of the public. The opening up revealed that all of the cast iron nails were corroded to some degree with some of the nails being badly corroded, and it is likely that the remaining nails are in similar condition. ***Based on our inspection and the opening work undertaken on the roof, it is our opinion that the slates and battens need to be removed. The slates should be salvaged as far as possible and replaced onto new battens fixed to the existing roof structure. Any necessary repairs to any decayed members should be carried out at the same time.***

Corroded nails taken from roof

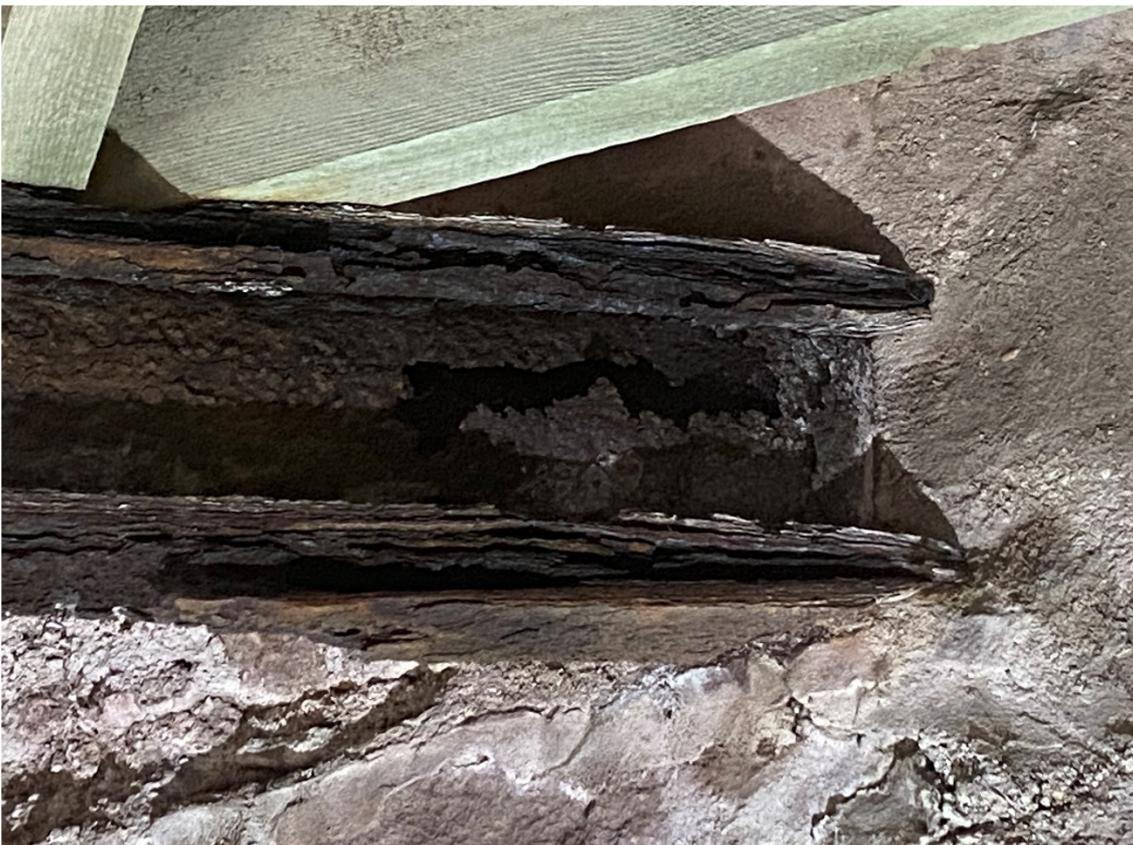
3. The uppermost floor in the belfry is supported by mild steel beams that appear to be heavily corroded and undoubtedly structurally weakened. ***The steel structure under the top floor in the belfry needs to be replaced, galvanised steel members.***

Steel beams under uppermost floor in belfry (looking upwards)

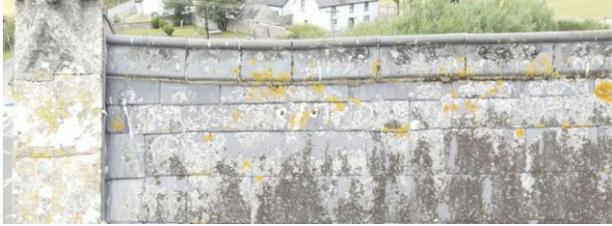
<p>Dip/sag in ridge to be investigated.</p> <p>Location: Nave - South West</p>

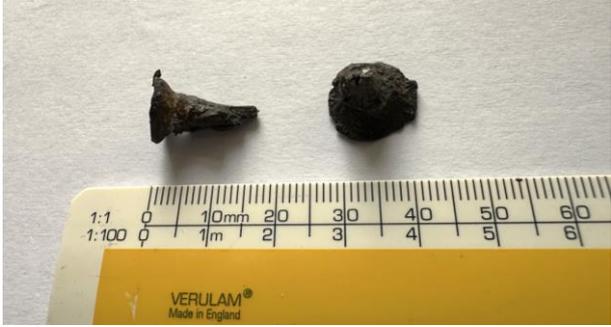
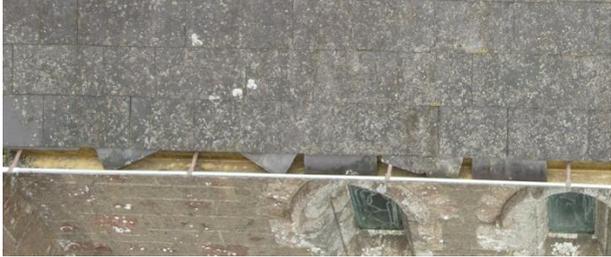
<p>Photograph of corroded slate fixings.</p> <p>Evidence of considerable slipped slate due to corroded fixings.</p> <p>Location: Nave - South East</p>

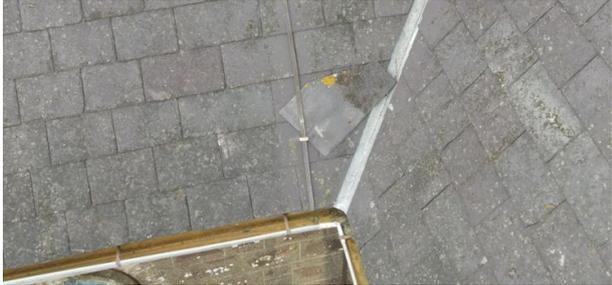
<p>Slipped slate visible at valley junction.</p> <p>Location: Nave - South West</p>

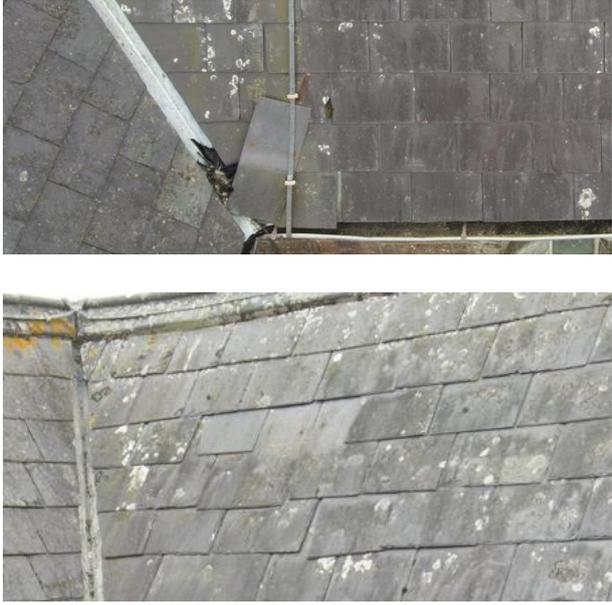
<p>Slipped and missing slates visible at valley junction.</p> <p>Location: Nave - North West</p>

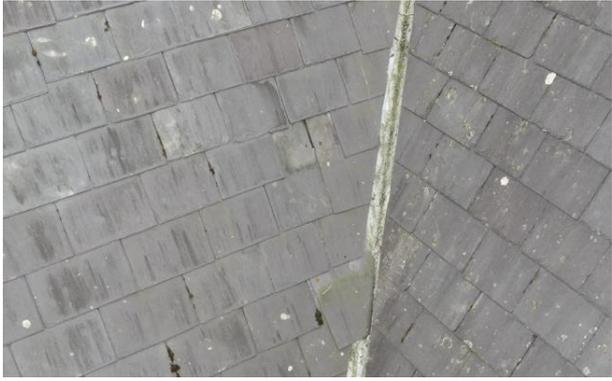
<p>Slipped and missing slates visible at valley junction.</p> <p>Location: Nave - North East</p>

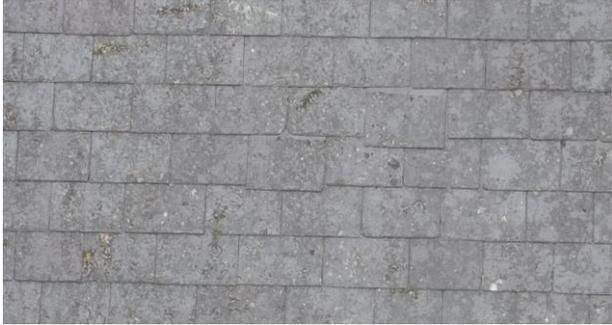
<p>Slipped slate visible projecting just above gutter.</p> <p>Location: Transept - South West</p>

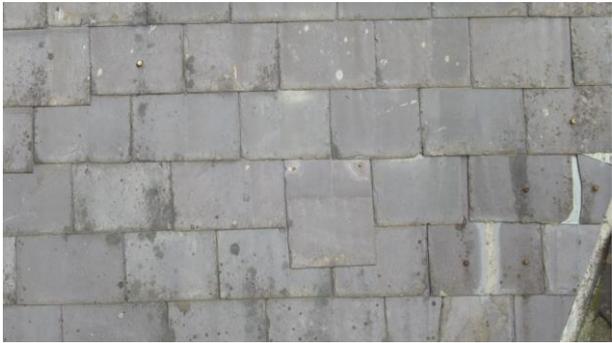
<p>Slipped slate visible, screw type fixings visible used previously to secure loose slate.</p> <p>Location: Aisle - South East</p>

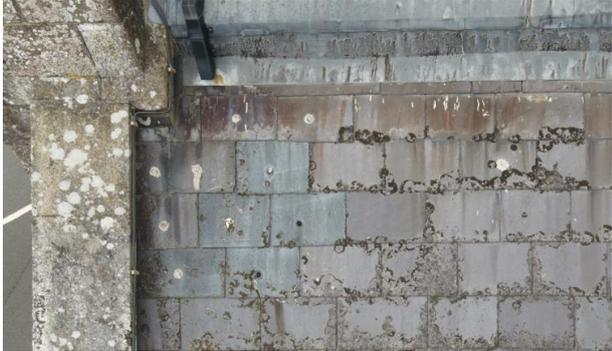
<p>Screw type fixings visible used previously to secure loose slate and visible silicone sealant repairs to slate also visible.</p> <p>Downpipe discharges directly to slate roof.</p> <p>Location: Aisle - South West</p>

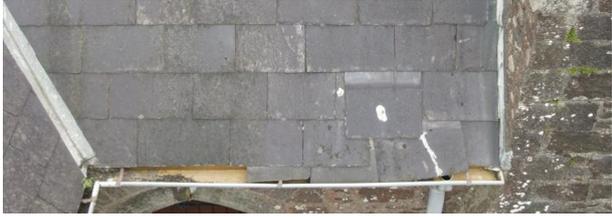
<p>Significant slipped slate adjacent to chimney.</p> <p>Location: Vestry – South</p>

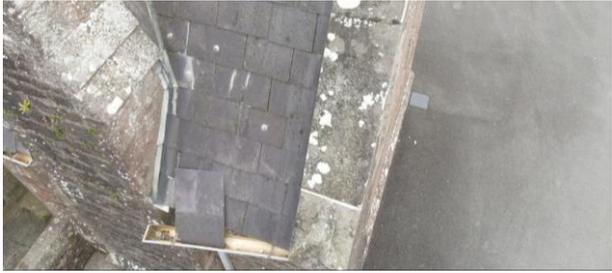
<p>Slipped slate adjacent to chimney along with broken gutter bracket.</p> <p>Location: Vestry – South</p>

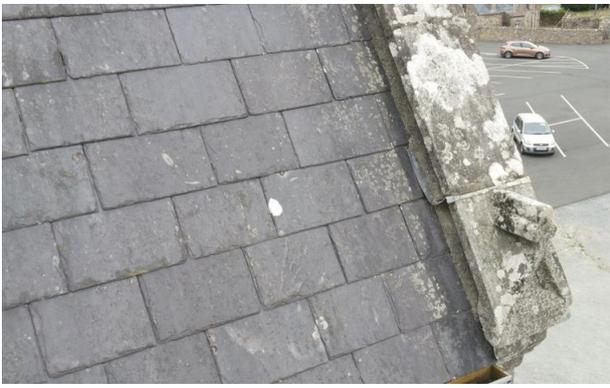
<p>Sand cement pointing visible to rear face of barge coping stone above lead soaker.</p> <p>Location: Transept – North East</p>

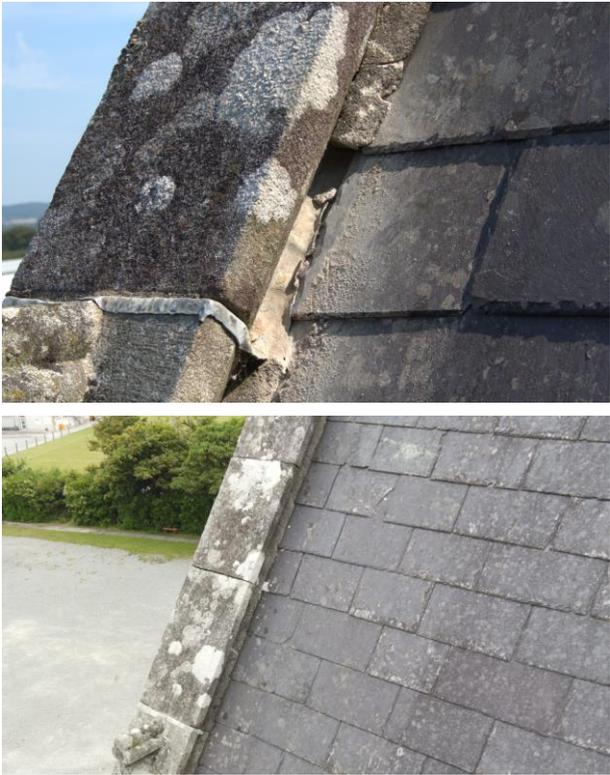
<p>Sand cement pointing visible to rear face of barge coping stone above lead soaker.</p> <p>Note: pointing eroded between coping stone. Cracked slate also visible</p> <p>Location: Transept – North West</p>

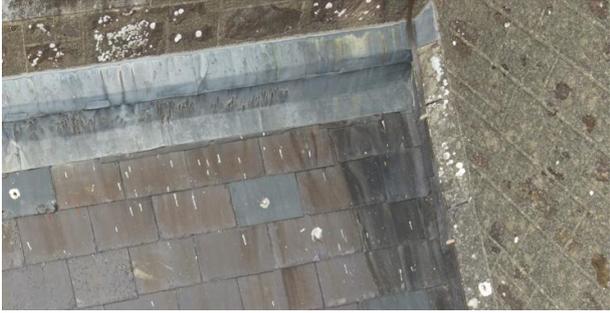
<p>Sand cement pointing visible to rear face of barge coping stone above lead soaker.</p> <p>Location: Aisle - South West</p>

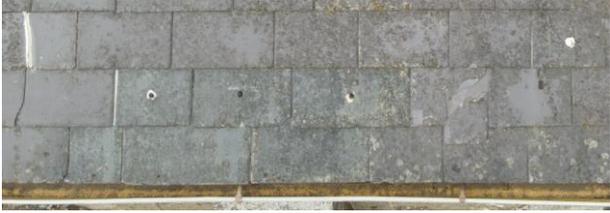
<p>Broken slate, slipping visible with screw type fixings used previously to fix slate.</p> <p>Location: Aisle - South West</p>

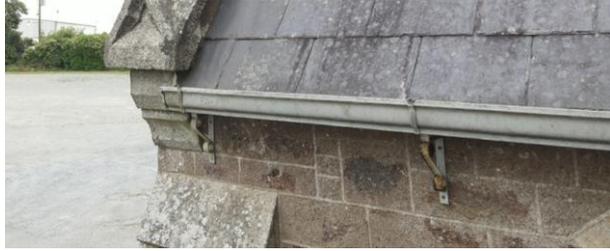
<p>Seamless Ogee gutter and brackets visible</p> <p>Location: Porch Roof - West</p>

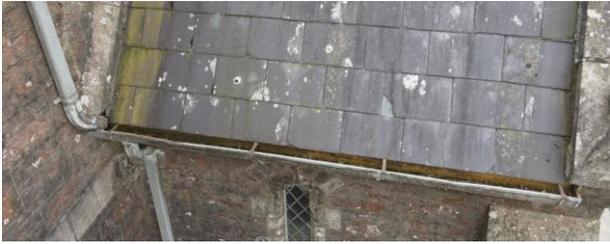
<p>Broken slate visible, screw type fixings used previously to fix slate.</p> <p>Seamless aluminum gutter & downpipe visible.</p> <p>Location: Porch Roof - East</p>

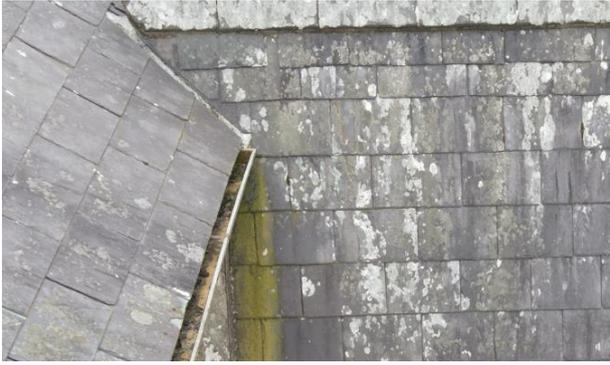
<p>Visible staining to slate roof due to compromised seamless aluminum gutter.</p> <p>Location: Porch Roof - East</p>

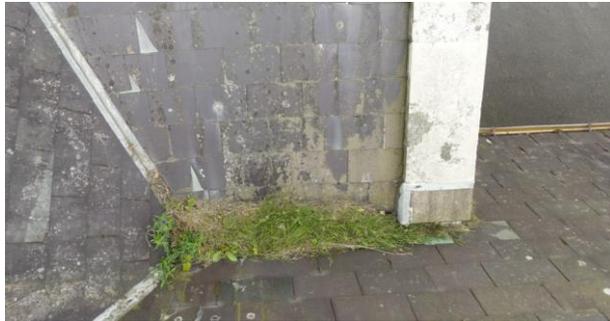
<p>Valley – blocked with vegetation and debris, new detail required.</p> <p>Location: Aisle - South East</p>

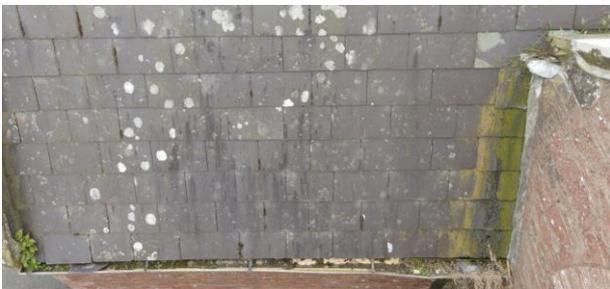
<p>Outlet to blocked valley (above), new detail required. Staining visible to slate and vegetation visible to barge.</p> <p>Location: Vestry - North</p>

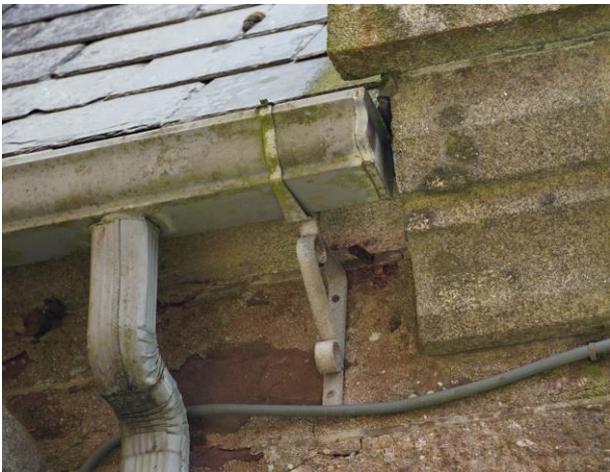
<p>Seamless aluminum gutter and downpipe and evidence of an older corroded bracket. From the piece remaining it cannot be determined if it is original.</p> <p>Inappropriate bracket</p>

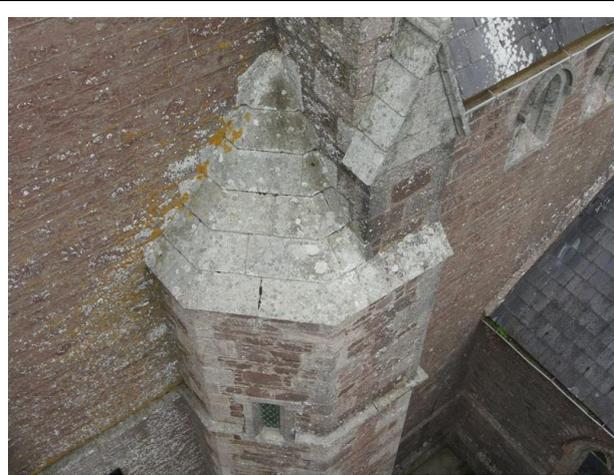
Location: Stair Tower

Granite roof detail to be repointed.

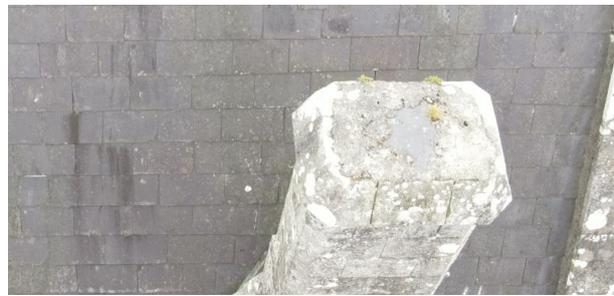
Location: Vestry - South

Condition of existing chimney to Vestry

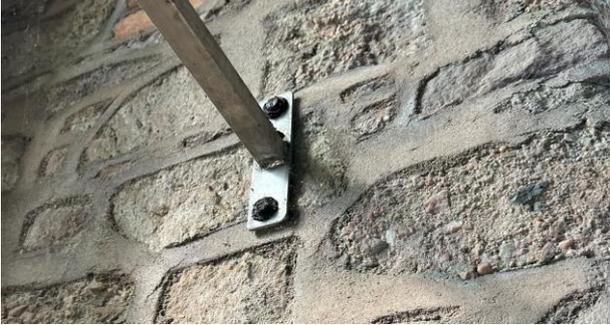
<p>Stainless steel ladder providing access up to the bell deck where the fixings are corroded and require replacement.</p> <p>Location: Stair Tower</p>

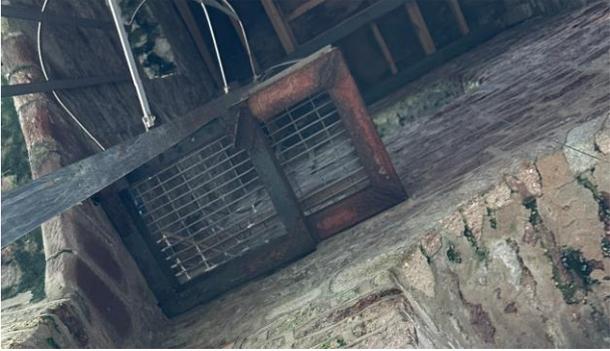
<p>Mild steel deck/landing to stainless steel ladder showing minor signs of corrosion</p> <p>Location: Bell tower</p>

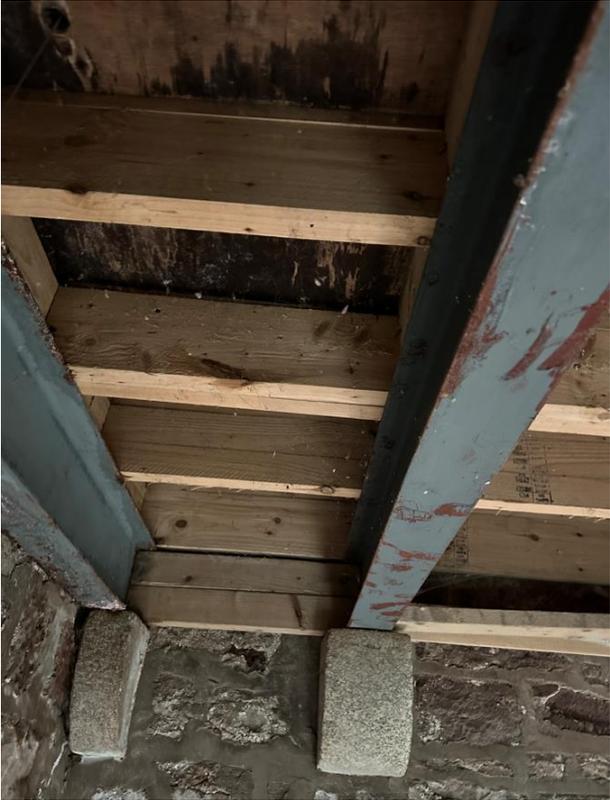
<p>Condition of existing steels and plywood supporting the belfry lead deck</p> <p>Location: Bell tower</p>

4. The deck / floor directly under the bell in the belfry consists of a lead covering over a plywood deck on timber joists on mild steel beams. The plywood deck appears to have some decay and as such, this deck should be replaced. ***Consideration should be given to replacing the lead covering and support joists when the plywood is being replaced. It was not possible to ascertain if the steel beams are embedded in the wall or bearing on the internal corbels. The ends of the steel beams should be examined for corrosion and replaced if necessary.***

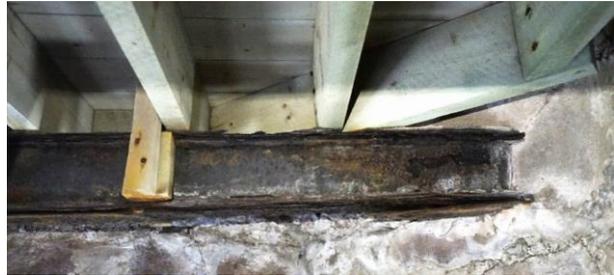
Location: Bell tower

Condition of existing steels sporting the
crash deck above the belfry
