Proposed repairs to Church of the
Assumption and Saint Laurence O'Toole,
Rathangan, Wexford (*a Protected Structure*)

Architectural Heritage Impact Assessment

MICHAEL TIERNEY
B Arch FRIAI
Conservation Architect Grade I
September 2025

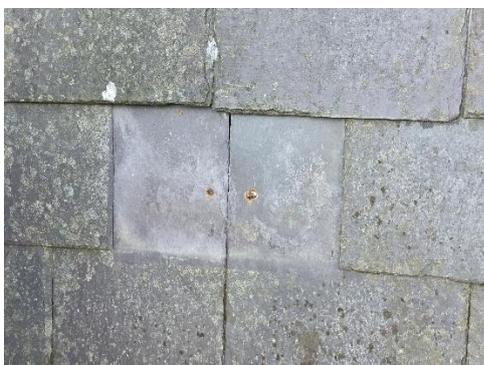
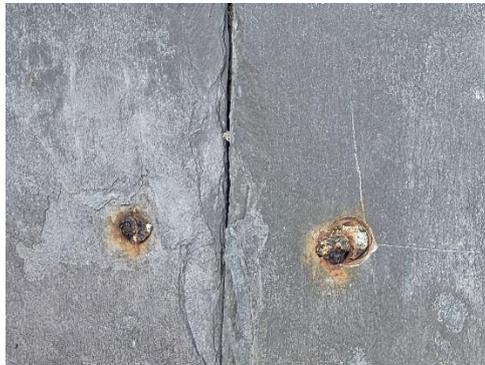
All gutters and downpipes to be replaced. / Past repairs to roof reveal some original nails were replaced with tek screws which are now corroding and resulting in slipping of slate roof files. Mostly an issue at the valleys and secondary roofs.

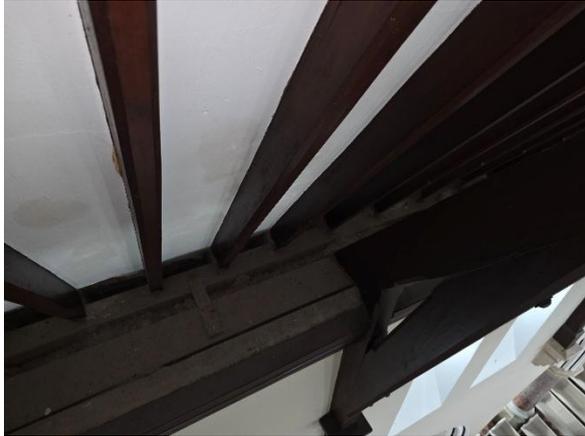
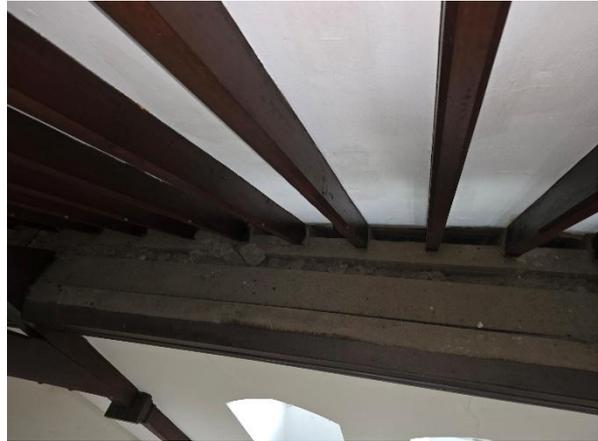
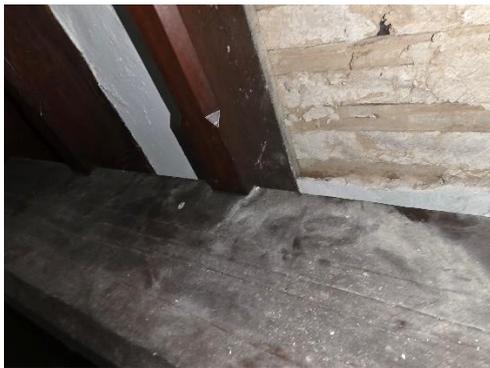
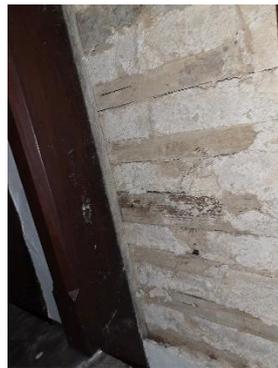
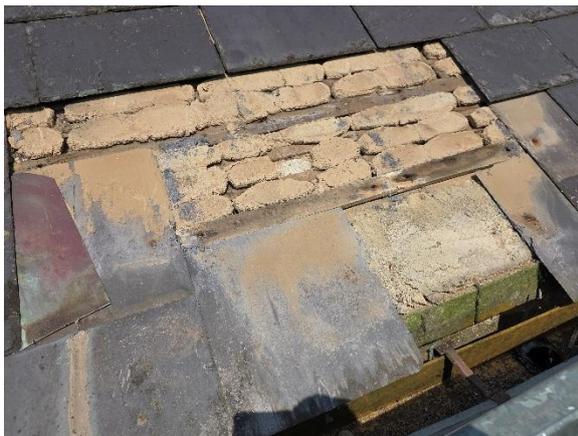
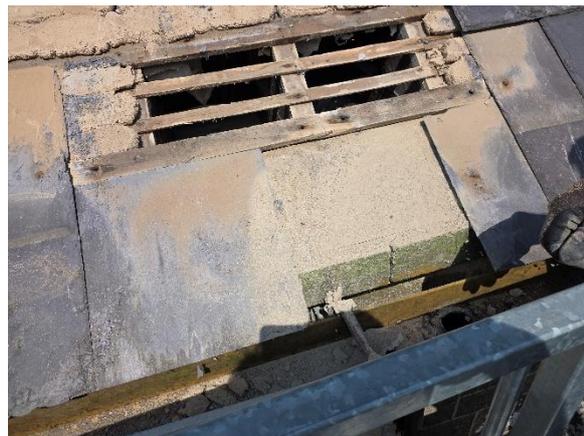
Timber roof structure in good condition. Approximate measurements of timber roof members:
rafters 124mm x 52mm at 300mm centres; purlins 220mm x 145mm; battens 50mm x 17mm;
plaster thickness 18mm.

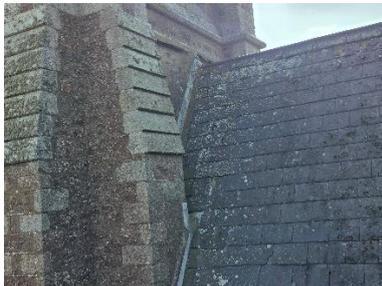
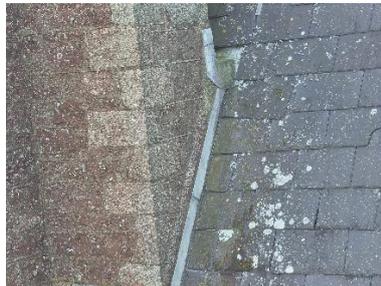
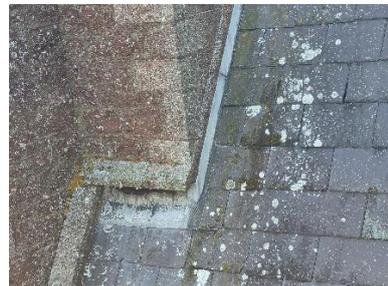
AREA 2 – PRIMARY ROOF

Lead valleys to be repaired.

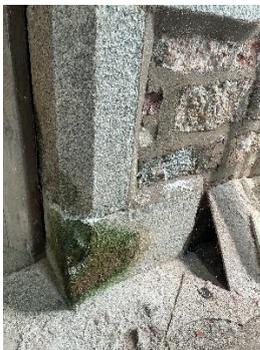
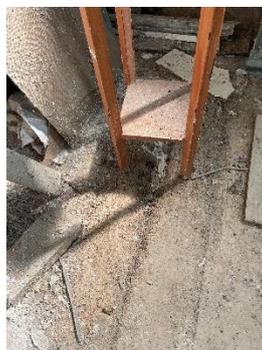
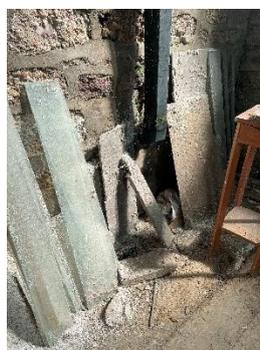
AREA 4 – TOWER INTERIOR

All 3 timber platforms in the tower are to be repaired. Platform 1 shows evidence of damaged and loose timber boards. Water damage from prior to downpipe installation/downpipe may currently be blocked. Existing bell motor to be enclosed in safety cage. Bolts to cat ladder badly corroded and need to be replaced.

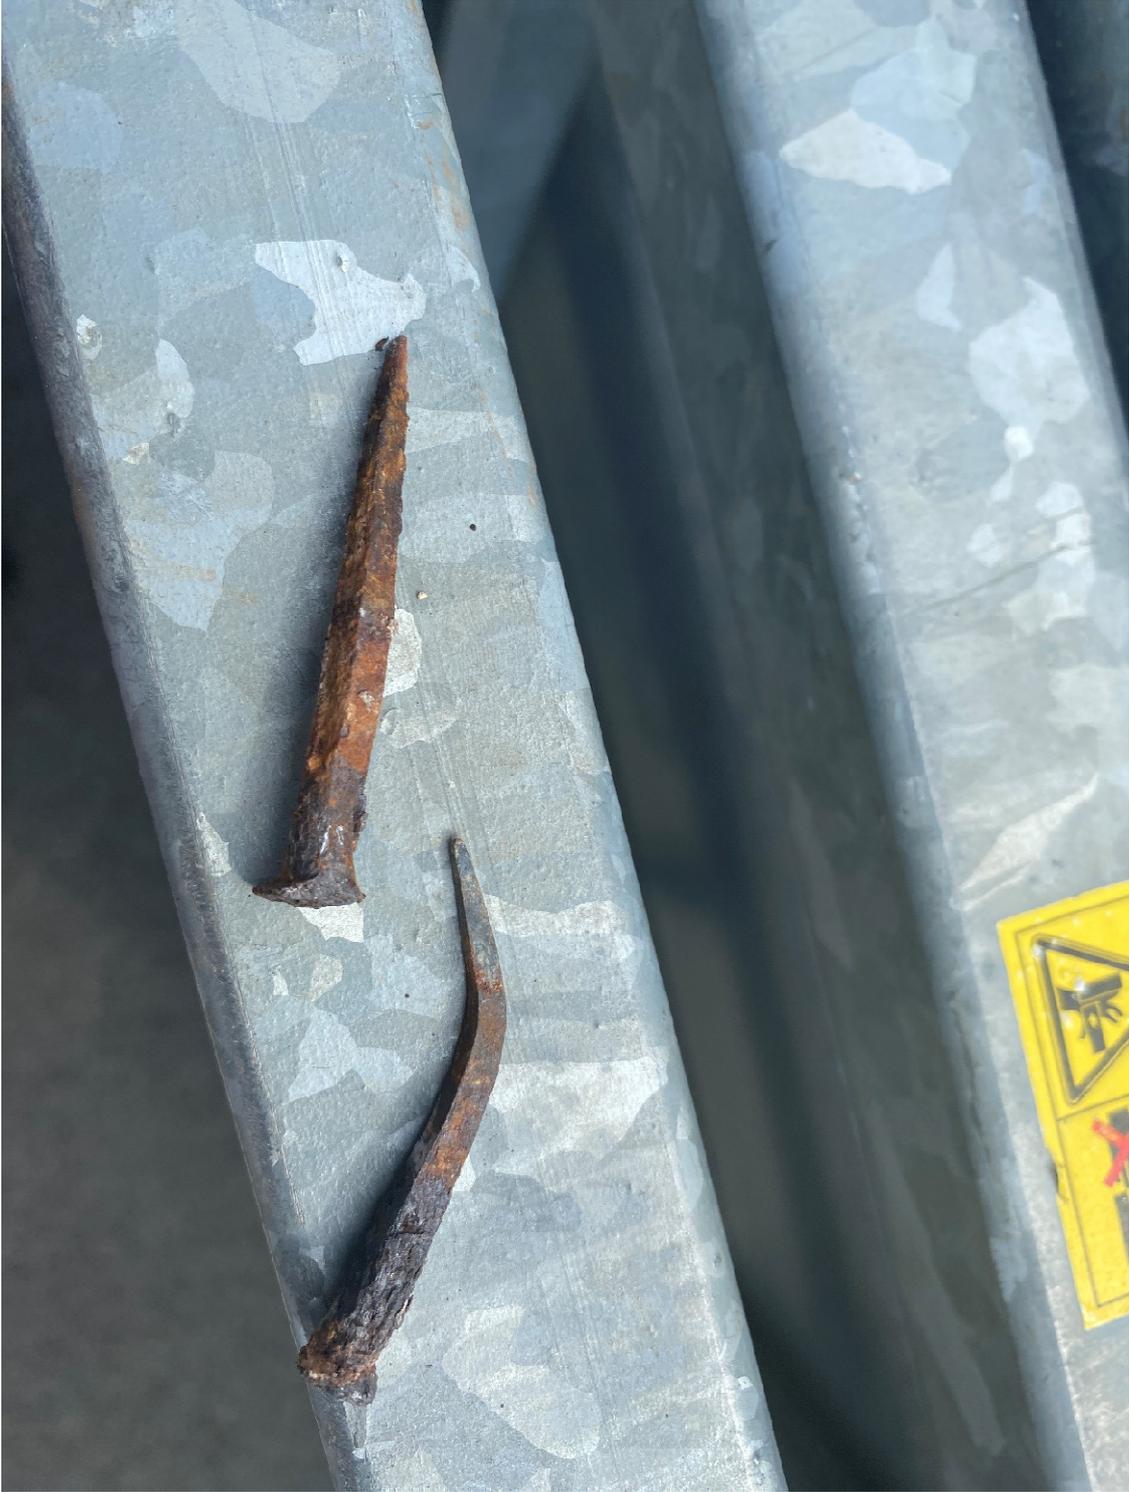
1. Many of the slates have 'slipped' and fallen off the roof. The nails in general are of iron construction and many have rusted through. 'Slipping' slates pose a grave danger to members of the public. The opening up revealed that all of the cast iron nails were corroded to some degree with some of the nails being badly corroded, and it is likely that the remaining nails are in similar condition. ***Based on our inspection and the opening work undertaken on the roof, it is our opinion that the slates and battens need to be removed. The slates should be salvaged as far as possible and replaced onto new battens fixed to the existing roof structure. Any necessary repairs to any decayed members should be carried out at the same time.***

Corroded nails taken from roof

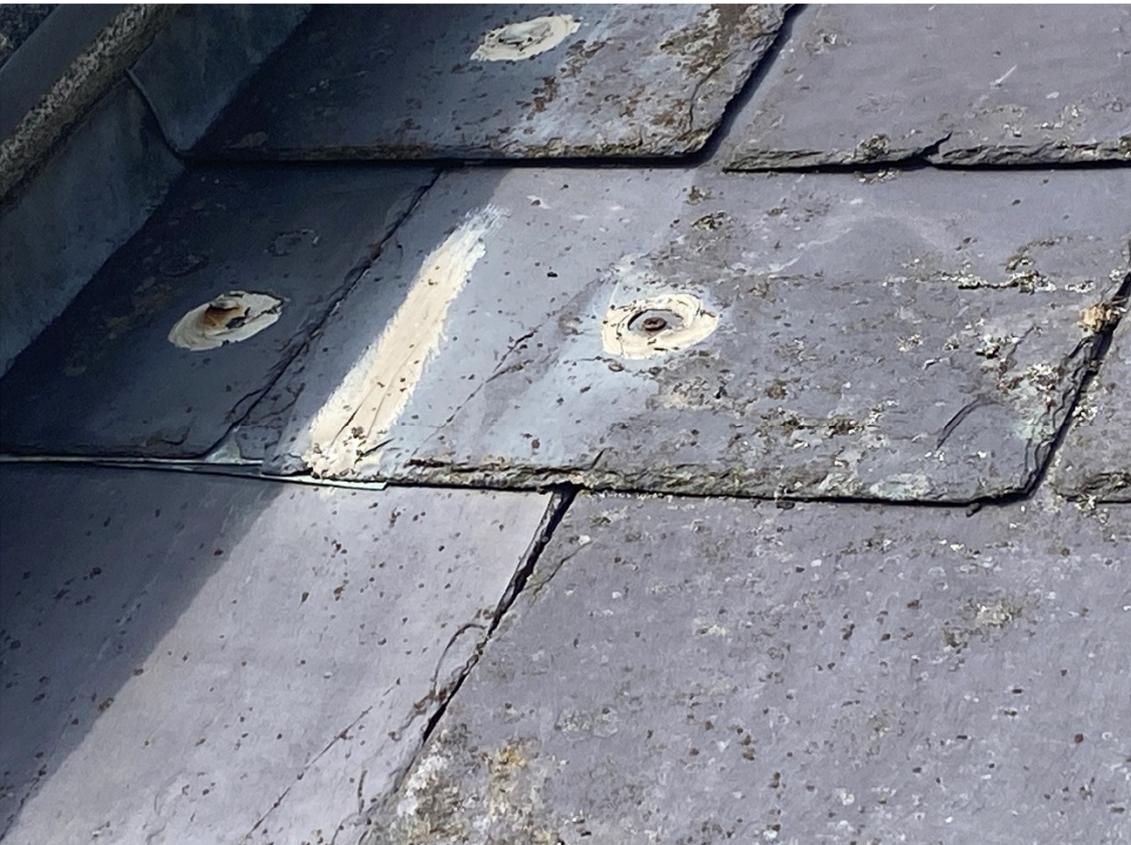
2. Many of the slipped and damaged slates have been screwed in place over recent years using modern 'Tek' screws, which will eventually allow water to ingress into the church. It can be expected that any such ingress will cause

the lime-based parging to fall off internally, causing further risks to members of the public attending the church. It appears that the lime-based parging may be holding the slates in place given the apparent failure of the corroded nails. ***Based on our inspection and the opening work undertaken on the roof, it is our opinion that the slates and battens need to be removed. The slates should be salvaged as far as possible and replaced onto new battens fixed to the existing roof structure. Any necessary repairs to any decayed members should be carried out at the same time.***

'Tek' screws holding slates in place over southern aisle

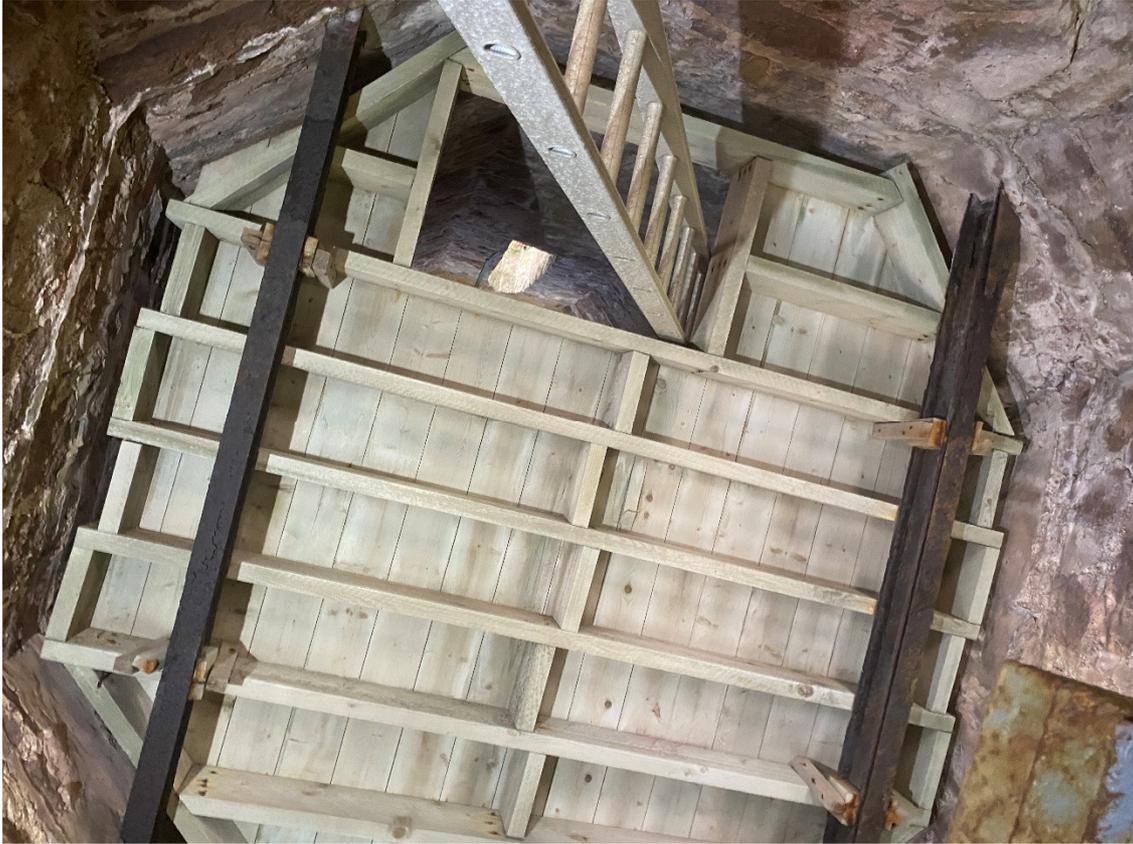
3. The uppermost floor in the belfry is supported by mild steel beams that appear to be heavily corroded and undoubtedly structurally weakened. ***The steel structure under the top floor in the belfry needs to be replaced, galvanised steel members.***

Steel beams under uppermost floor in belfry (looking upwards)

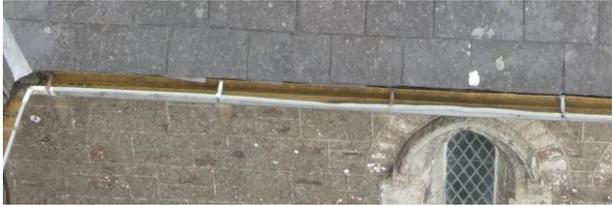
<p>Slipped slate visible projecting just above gutter.</p> <p>Location: Transept - South West</p>

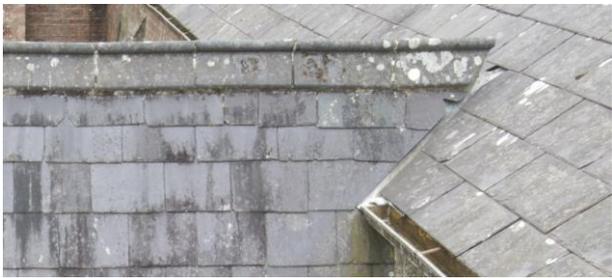
<p>Significant slipped slate adjacent to chimney.</p> <p>Location: Vestry – South</p>

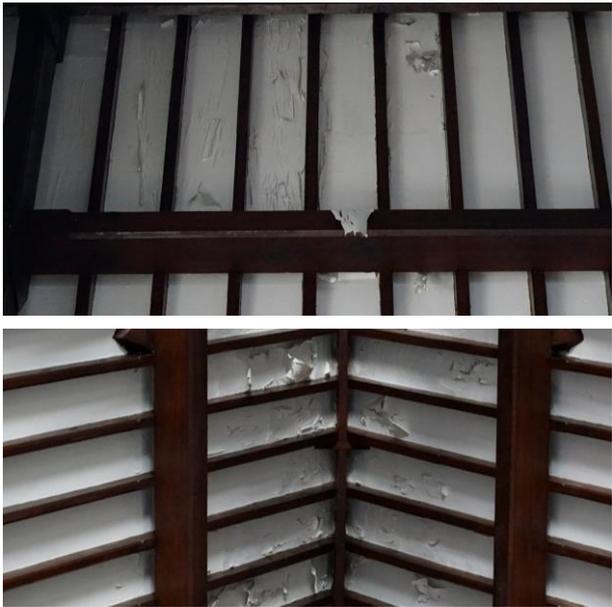
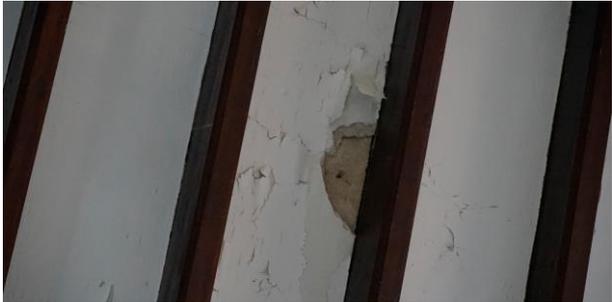
<p>Lime parging showing signs of significant rainwater ingress.</p> <p>Location: Ceiling Nave/Transept</p>

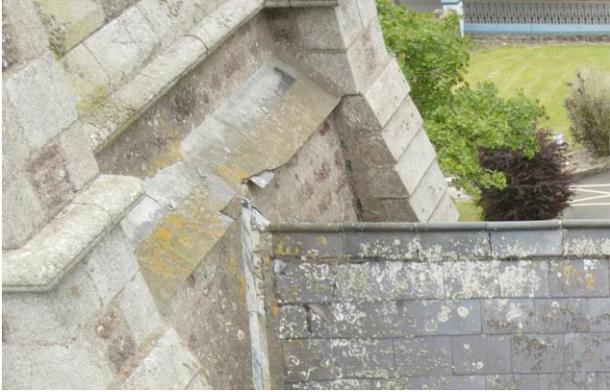
<p>Sand cement pointing visible to rear face of barge coping stone above lead soaker.</p> <p>Location: Transept – North East</p>

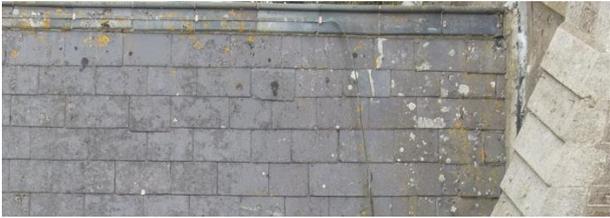
<p>Asbestos slate visible on slate roof.</p> <p>Location: Boiler house roof</p>

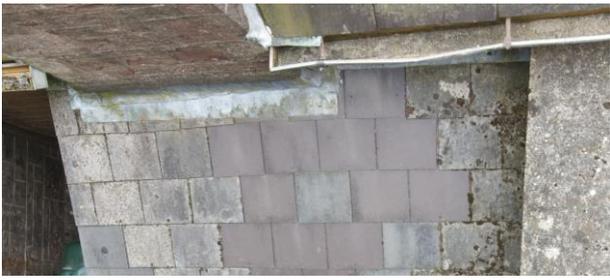
<p>Vegetation growing from the valley between the vestry pitched roof and the pitched roof abutting the chimney.</p> <p>Location: Vestry West</p>

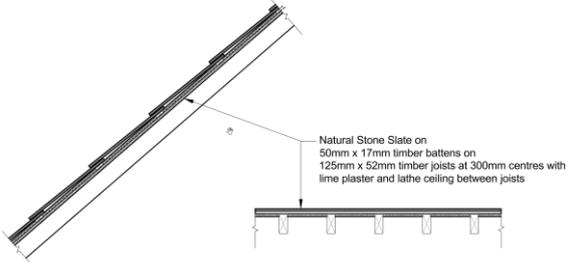
<p>Existing roof build up:</p>

<p>Natural Stone Slate on 50mm x 17mm timber battens on 125mm x 52mm timber joists at 300mm centres with lime plaster and lathes on underside</p>	<p>Proposed roof build up:</p>

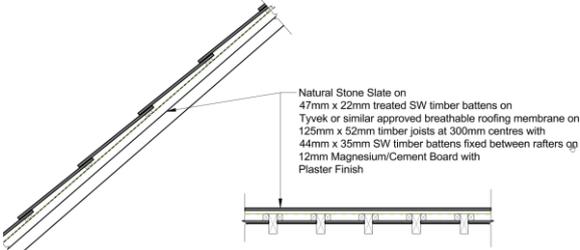
<p>Natural Stone Slate on 47mm x 22mm treated SW timber battens on Tyvek or similar approved breathable roofing membrane on 125mm x 52mm timber joists at 300mm centres with 44mm x 35mm SW timber battens fixed between rafters on 12mm Magnesium/Cement Board with Plaster Finish</p>
<ul style="list-style-type: none"> • Existing Welsh slate on • Timber battens with • Intermediate timber lathes on • Existing decorative exposed roof timber timbers and with • Painted lime parging/plaster to underside 	<ul style="list-style-type: none"> • Proposed new slate on • 47x22mm treated softwood timber battens on • Breathable Tyvek Supro or equal approved on • Existing decorative exposed roof timber timbers with • 44 x 35mm timber battens fixed between rafters with 12mm magnesium/cement board with plaster and paint finish to underside
